Space building case

Jeisson D. Coral C.

Article typology: Research

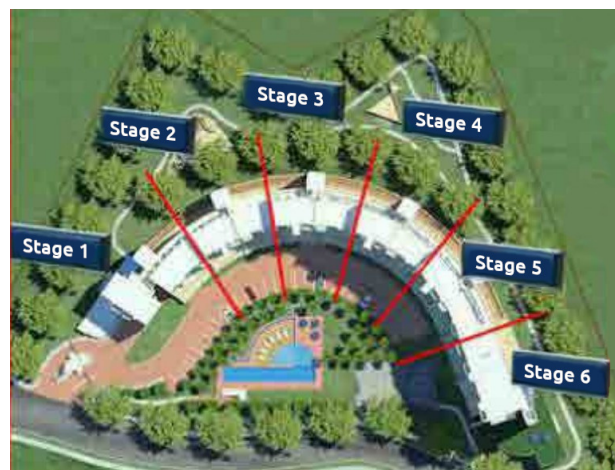
Figure 7. Space building structure design (Suárez, 2019).

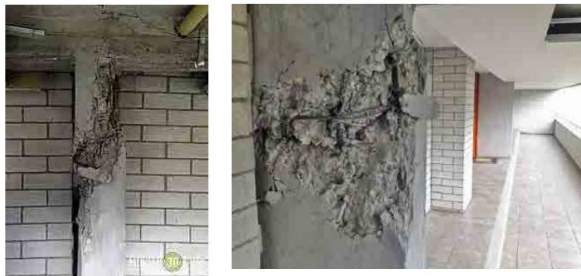
Problems in the combined structural system began to become evident in the columns that were the first to fail and the plates began to sag, in addition, cracking was seen

in many main and dividing walls of Tower 6 (Fig. 8). On Friday morning, October 11, 2013, the inhabitants of the Space Building contacted the Administrative Department of Disaster Risk Management (DAGR) because a column of Stage 6 had failed (Toro, Yepes, & Castaño, 2016). This entity observed the problems and the structural failure of the column, therefore, decided to evacuate Stage 6 of the Space Building. For which the construction company stated: "There is no danger for the rest of the building where no structural failure was found".

Figure 8. Photographs of the columns before collapse (Suárez, 2019).

The primary cause of the collapse of the SPACE building lies in the lack of structural capacity of the building's main columns to resist the acting loads due to the structure's weight and the imposed service loads (Fig. 9). In particular, the columns of the R-3 and S-3 axes presented acting loads that exceeded their capacities at critical points, which caused them to present structural failure by compression on February 20, 2013, and October 11, 2013, the latter one day before the collapse of the building. The lack of structural capacity is associated with deficiencies in the sizing and design of the main structural elements (columns, beams, and slabs).

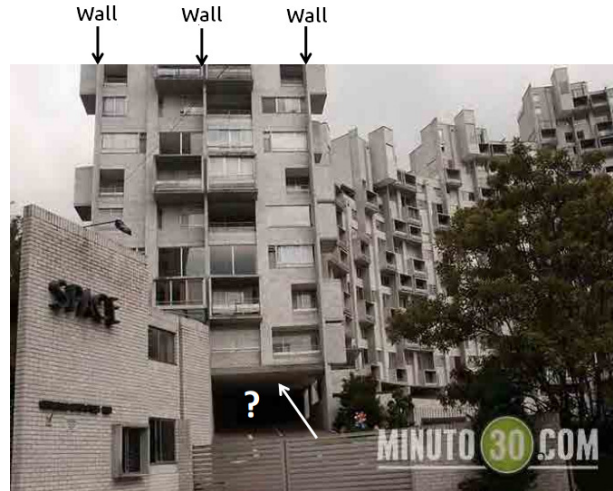
There is evidence that the building suffered from internal structural problems and pathologies in the months and days before the collapse which include cracks and crevices in masonry partition walls, excessive vertical deflections in the floor slabs, and structural failures in at least two main columns of the building (Fig. 10) (Buitrago, Callejas, & Moreno, 2018; Toro et al., 2016).

Figure 9. Lack of continuity in structural walls (Suárez, 2019).

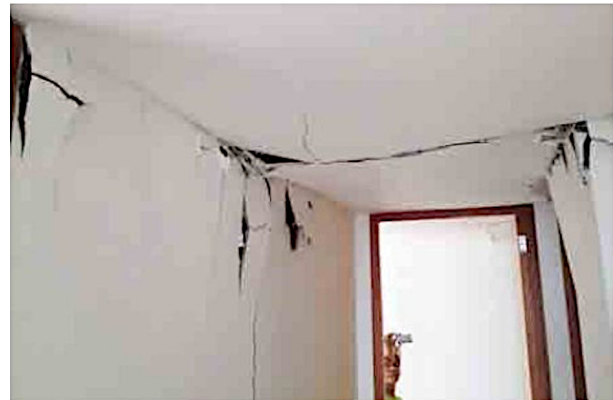
Figure 10. Cracks and fissures in dividing walls (Suárez, 2019).

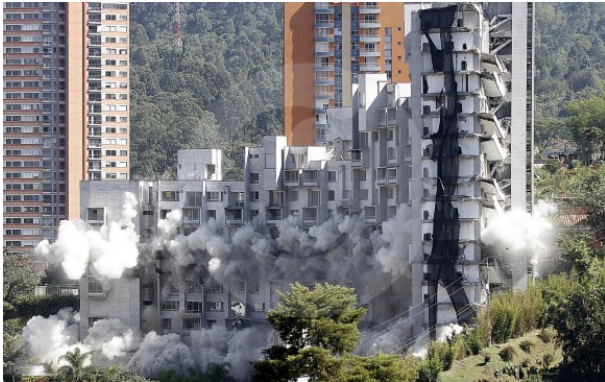
After the collapse of Tower 6, the other towers were demolished because it was concluded that all of them had structural design flaws after studies conducted by the Universidad de Los Andes and the prosecutor's office said: "the columns were not thick enough to support their weight. In addition, it found that there were 5,500 transgressions to the seismic resistance standard in the entire residential complex" (Fig. 11).

Figure 11. Demolition of towers 1, 2, 3, 4 and 5 (Mercado, 2019).

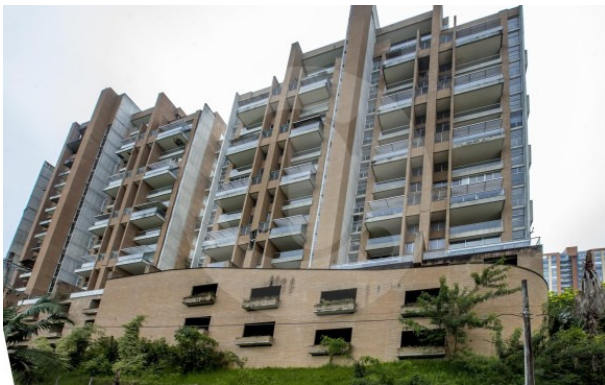
In the case of Continental Towers, one of the buildings evacuated shortly after the collapse of the Space tower, according to the specialist Roberto Rochel, professor at Eafit, it is better to demolish it than to repair it (Fig. 12). The fact that not one but several buildings were evacuated to study their structures, both in El Poblado and in other areas of the city, highlights the probable existence of a systemic problem and not a specific one (Mundo, 2013).

Figure 12. Continental Tower photo, October 2018 (Sánchez, 2019).
