Space building case

Jeisson D. Coral C.

Article typology: Research

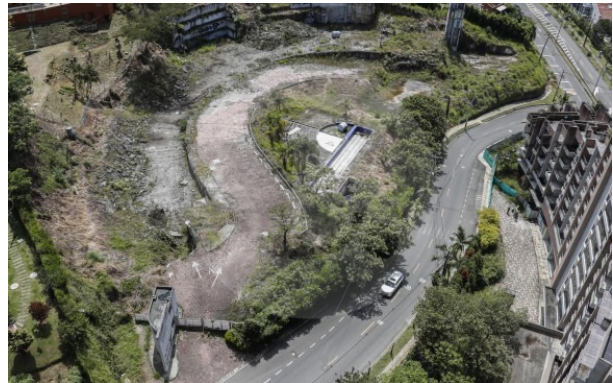
After the collapse of tower 6 of the Space building in the El Poblado sector in Medellín, to the disbelief of the people of Antioquia, who believed that these towers were made to last until the end of time, the disbelief increased even more, when several buildings were evacuated for possible construction deficiencies and that had been built or were being built by the company CDO as the Continental Tower building which was one of the buildings evacuated a few days after the collapse of Tower 6, The fact that not one but several buildings were evacuated to study their structures, both in El Poblado and in other areas of the city, highlights the probable existence of a systemic problem and not a specific one (Fig. 13). This case helps to demonstrate that people trust in the durability and resistance that a structure may have because of its aesthetics or architectural design, but they do not see the internal part of the structure which was the cause of the collapse that over time became more evident;

the damage to the columns, the cracks that were created in the main walls and finally a sudden collapse.

Figure 13. Lot of the Space building after demolition (Sáenz, 2019).
